WEST VIRGINIA OFFICE OF MINERS' HEALTH, SAFETY AND TRAINING

REPORT OF FATALITY  
RIB ROLL  
JUNE 2, 2021

MARION COUNTY COAL RESOURCES

MARION COUNTY MINE

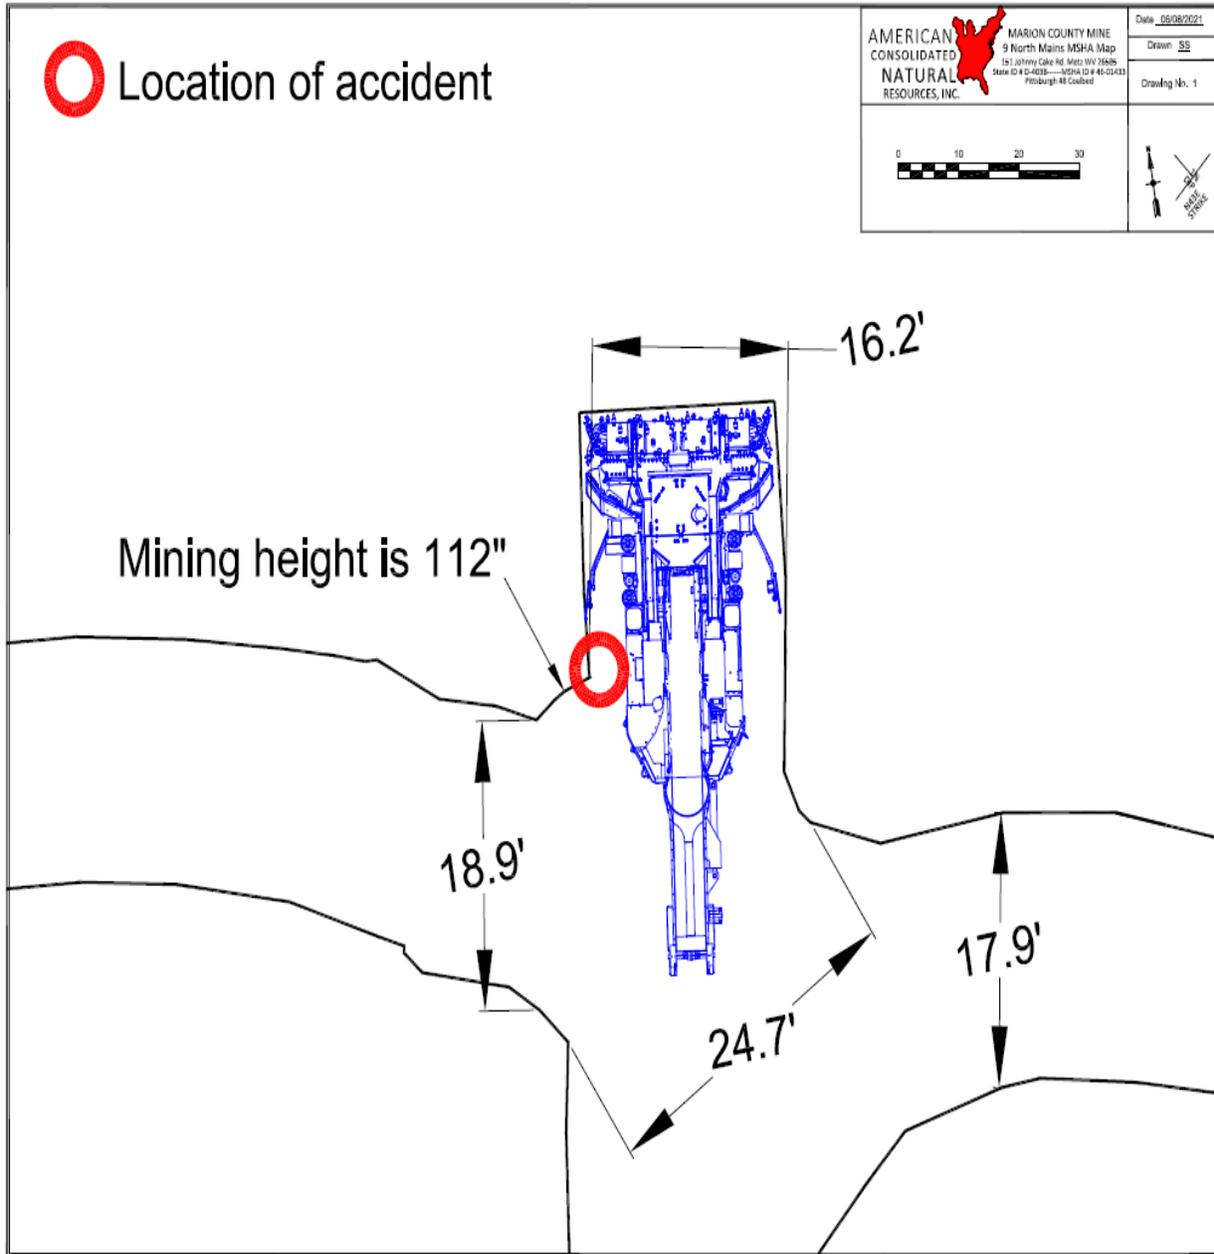
- 12) Mr. Dille used an auger/twist drill steel to drill the hole for the rib bolt.
- 13) The crack in the rib was vertical and extended from the middle of the coal seam to the rock binder at the mine roof.

- 14) Interviews revealed that the crack was ½" to 2" in width.
- 15) Mr. Dille had acknowledged the crack in the coal rib.
- 16) The drill hole for the rib bolt that Mr. Dille drilled intersected with the wide crack.

- 22) The mining height at the accident site measured 112".
- 23) The coal/rock that struck Mr. Dille fell from the top of the square corner and was attached to the rock binder above the coal seam.

- 24) After the accident occurred and prior to the underground investigation, an additional piece of the square coal corner at the accident site fell.
- 25) The coal/rock that struck Mr. Dille measured 6'3" in length, 2' in width, 4'8" in height and weighed approximately 2100 pounds.

- 26) When the coal/rock fell, it came down on its end and the top end of the coal/rock fell over striking Mr. Dille and pinning him against the bolter station on the continuous miner.

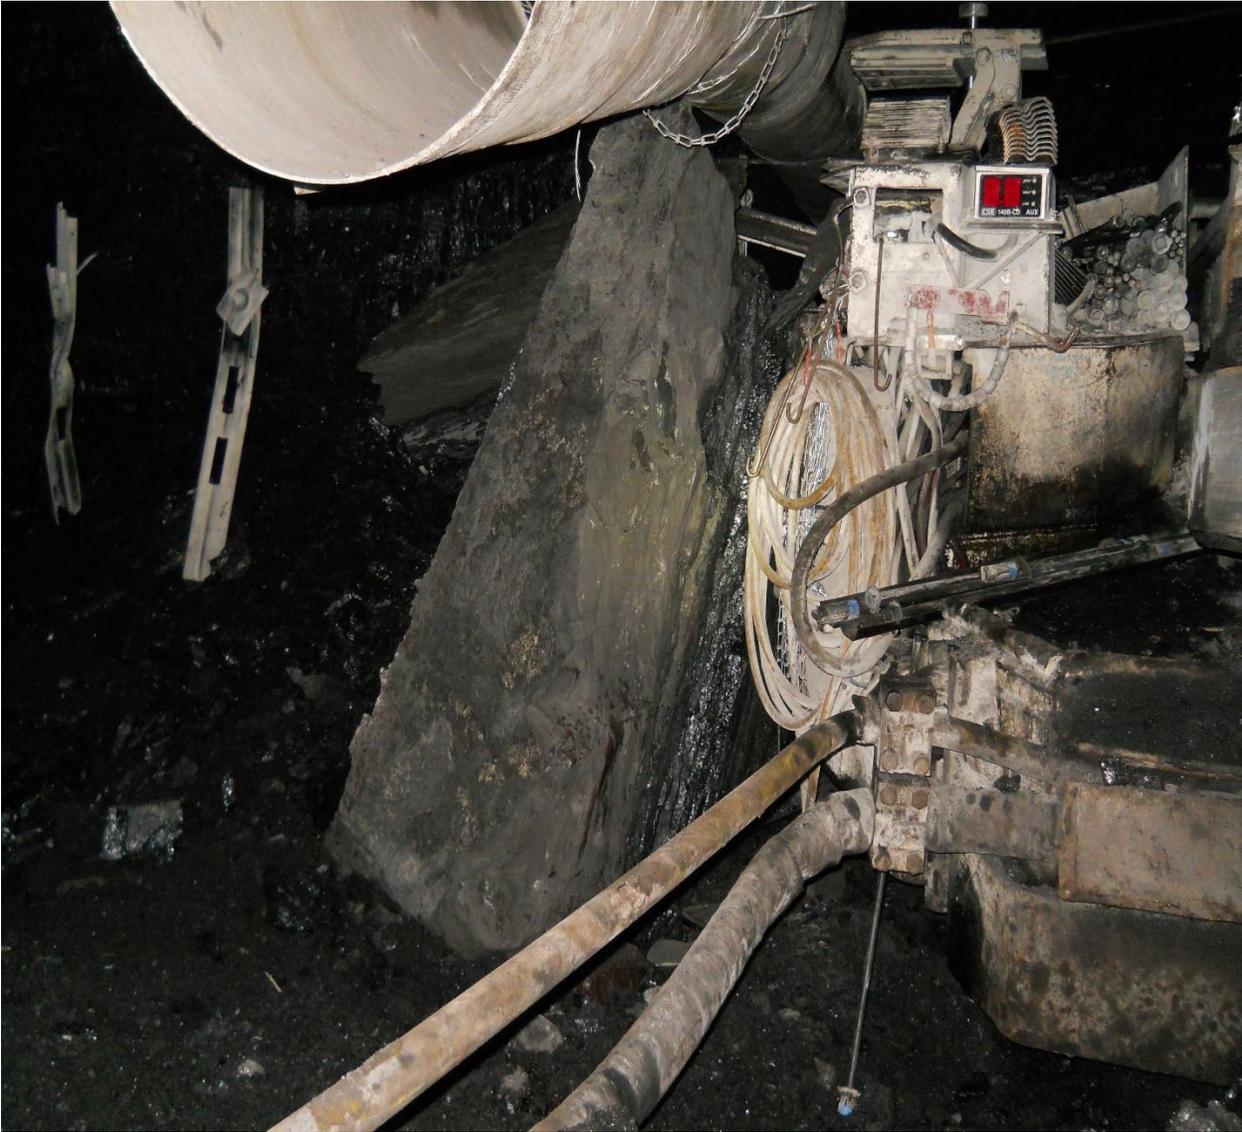
Mr. Dille was fatally injured while attempting to install a rib bolt on the 9 North Mains section in the #6 entry at #51 block on June 2, 2021, at approximately 2:08 a.m. The victim was positioned at the back, left side of the continuous miner at the rib bolting station. The victim was attempting to install a rib bolt when a rib roll dislodged, fatally crushing the victim.
